Dose Rate Upset Investigations on the Xilinx Virtex IV Field Programmable Gate Arrays

Abstract--The following paper describes the results of ionizing dose rate investigations into upset, supply photocurrent, latch-up, and burnout susceptibility of the Xilinx Virtex IV XC4VFX12. All investigations were performed on a commercial version of the device. Two printed circuit cards were used in the testing – one commercial board by Memec was used for upset testing and one custom board was used to monitor supply photocurrent, latch-up and burnout. The maximum no-upset dose rate was 2.8×10^8 rad(Si)/s. Photocurrent amplitudes as a function of dose rate were recorded and are consistent with expectations for devices fabricated on a bulk silicon substrate. Following a dose rate of 6×10^9 , one device exhibited an uncontrolled state, which could not be recovered without cycling the power supplies.

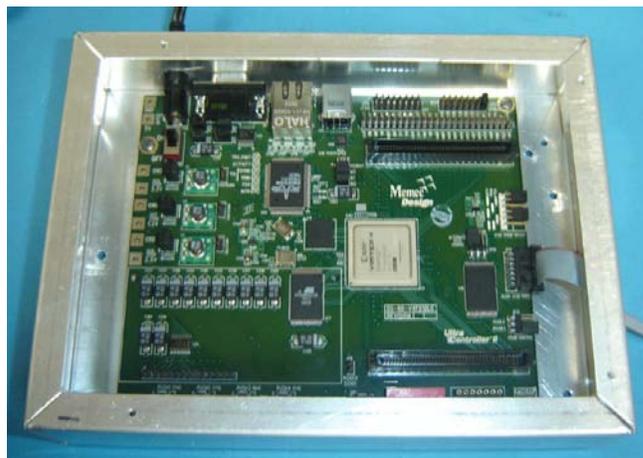
Fig. 1: Xilinx's Virtex-4 FX XC4VFX12-FF668LC Development kit. For testing, the LCD panel was removed and the board was placed in a box, with lead protecting all the components but the FPGA.

dividing the test into two efforts – (1) one directed toward upset testing and (2) the other directed toward photocurrent and latch-up characterization. Upset testing can be performed on a commercial board designed to support development and technology evaluation. The commercial board used for the upset test in this effort is shown in Figure 1. The active support electronics are located on the board, but these components are far enough away from the Virtex 4 to permit them to be shielded. The board includes its own voltage regulators to provide 1.2 volt, 2.5 volt and 3.3 volt power to the device under test. A large number of bypass capacitors are included very close to the Virtex 4 to prevent voltage droop under high speed operation and to suppress noise on the supply lines. The power supply system design unfortunately also precludes easy monitoring of the photocurrent on the supply lines. It also prevents the supply current from being limited during a potential latch-up condition, making the Virtex 4 susceptible to burnout if latch-up occurs. If catastrophic damage does occur, the entire board must be discarded, since the FPGA is in a ball grid array (BGA) package directly soldered to the printed circuit board. However, since the fully populated board costs less than \$450 (US), the risk is acceptable, since a more elaborate board engineering effort would easily cost far more. Once upset testing was completed on the commercial development board, a much simpler board (Figure 2) was designed for the sole purpose of monitoring photocurrent on the power supply lines and monitoring/limiting current during latch-up testing. Naturally, the simpler board included provisions for loading the FPGA configuration into the device under test, and monitoring its performance. However, only five CMOS output channels were made available for monitoring.

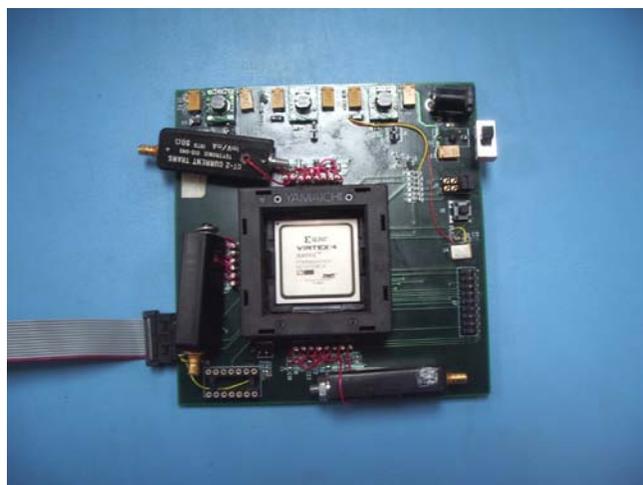
Fig. 2. Custom board design for monitoring photocurrents for the three XC4VFX12 power supplies – V_{core} , V_{aux} , $V_{\text{I/O}}$.

The photocurrent board used three Texas Instruments PTH04070WAH on-board voltage regulators driven from a common 5 volt supply to provide the three categories of supply voltage – core, aux, and I/O. The FPGA voltage pins dedicated to the specific supply voltages were connected by multiple printed wiring traces and each of the traces was bypassed by a stack of

ceramic capacitors with values of $10\mu\text{F}$, $1\mu\text{F}$, $0.1\mu\text{F}$, and $0.01\mu\text{F}$.

The board was designed so that a Tektronix CT-2 current probe could be inserted between the bypass capacitor stack and the FPGA voltage pins. This permitted the photocurrent for each voltage supply to be recorded independently.

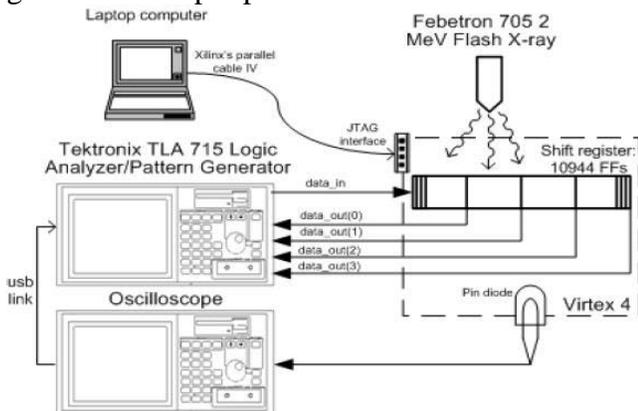
Fig. 3: Instrumentation diagram.

For the two shift register configurations, the on-board 25 MHz clock was buffered out of one of the I/O ports and used to synchronize the FPGA clock with the data stream from a logic analyzer/pattern generator (Tektronix model TLA 715) as shown in Figure 3. The shift register was tapped at four equally-spaced locations in the chain, and the output was brought out to an I/O port. The logic analyzer/pattern generator was used to monitor the outputs of the register and to generate the input pattern.

The Tektronix TDS-5054 oscilloscope monitored the clock output, two of the shift register outputs, and the response of the PIN diode used for secondary dosimetry. The oscilloscope was triggered by the response of the PIN diode and provided the trigger for the logic analyzer data capture so that the two instruments were synchronized.

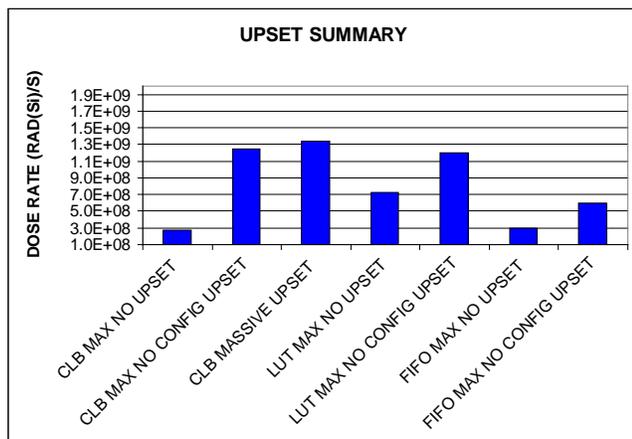
Fig. 4. Data and configuration upset summary

Figure 4 summarizes the data and configuration upset conditions for the XC4VFX12. The lowest upset threshold was determined by upsets in the clock. A dose rate of 2.8×10^8 rad(Si)/s was the maximum dose rate that produced no clock errors in either the CLB shift register configuration or the FIFO configuration. As shown in Figure 5, a clock upset at a dose rate of 3×10^8 rad(Si)/s was typical of this upset characteristic.

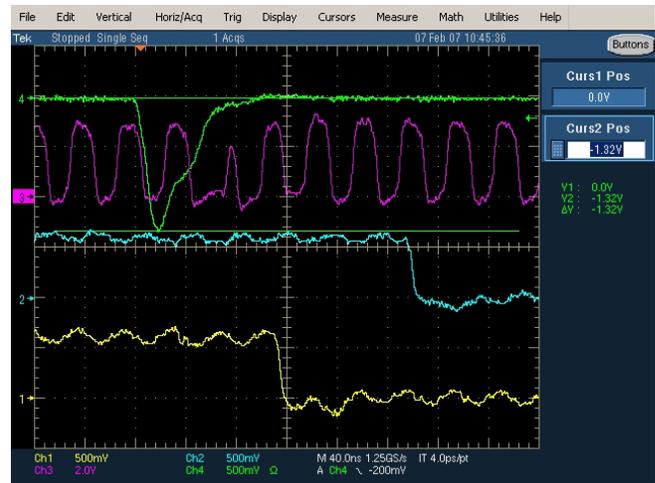
Fig. 5. Clock upset in the CLB shift register configuration

A latency of one clock cycle between the radiation pulse and the first clock upset was typically observed. This indicates that the upset was probably not associated with the output driver, but was most likely determined by the photo-response in the clock management unit.

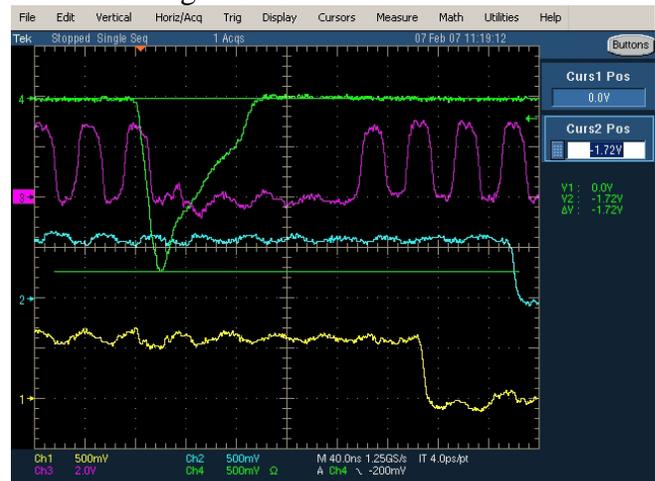
Fig. 6. Clock upset produces “stretch out” in data stream for CLB shift register configuration

As shown in Figure 6, multiple cycle upsets in the clock produced a “stretch out” in the period of the data being cycled through the shift register. This was a further indication that the upsets were occurring in the clock distribution network and affecting the clocking of the individual flip flops in the shift register.

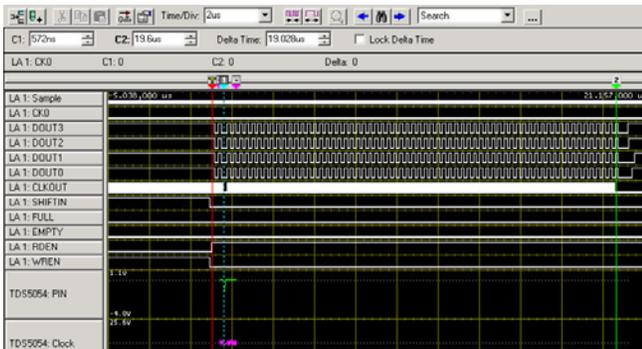
Fig. 7. Data upset latency in a FIFO configuration with multiple configuration errors

In all cases, the configuration upset occurred at significantly higher thresholds than the clock upset. The lowest configuration upset was observed in the FIFO. Upset occurred at 6.0×10^8 rad(Si)/s, which was approximately a factor of 2

below the threshold of the other configurations. These upsets were typically associated with a latency in the errors observed in the data. Such a case is shown in Figure 7, where the radiation pulse occurrence is indicated by the dashed green line and can be seen to interrupt several clock cycles. However, the data output channels recovered and appeared to be fully operational for 21 microseconds before becoming unstable. The FPGA was found to have 1556 configuration errors when it was examined after the test.

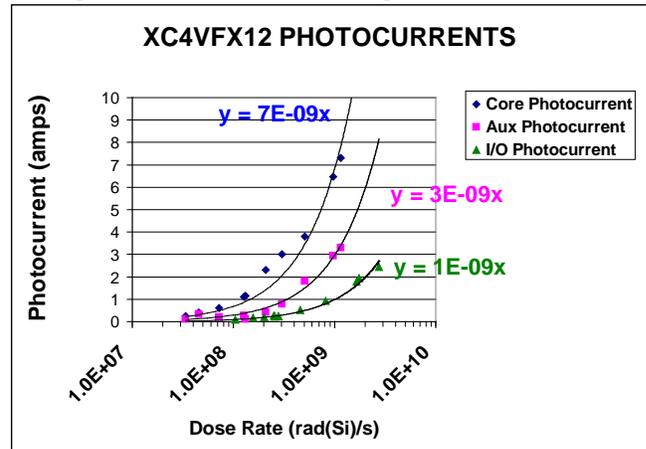
Fig. 8. Photocurrents for the three voltage supply types used in the V4 FPGA

The photocurrent monitoring board was used to test two FPGAs to determine photocurrent as a function of dose rate. Supply photocurrent was recorded for each of the three supplies. Dose rates ranged between 3.4×10^7 and 6.2×10^9 rad(Si)/s. The results for each of the power supply types are shown in Figure 8. As might be expected the photocurrent of the core supply was dominant. The auxiliary and I/O showed significantly less photocurrent. However, only five of the CMOS I/O were used and the

remainder was unconfigured. Similarly, none of the circuitry served by the auxiliary supply was configured. Their response may have been greater for an actual application. The core was configured for a CLB shift register.

Linear equations were fit to each of the data sets and the resulting curves are plotted in Figure 8. The fits were made to the low dose rate data ($< 10^8$ rad(Si)/s) and extrapolated to the higher dose rates. For the core supply, the photocurrent trends super-linear beginning around 10^8 rad(Si)/s, possibly indicating the turn-on of parasitic bipolar devices associated with the well and substrate. At dose rates above 10^9 rad(Si)/s the currents begin to saturate with a maximum peak value of 8.8 amps. The printed circuit board trace resistance of the power supply network may have contributed to the photocurrent saturation. After each photocurrent test, the configuration of the FPGA was monitored. For these series of test, the configuration was lost at dose rates as low as 7×10^7 rad(Si)/s. Most likely, this was caused by the lack of bypass capacitance very close to the supply pins.

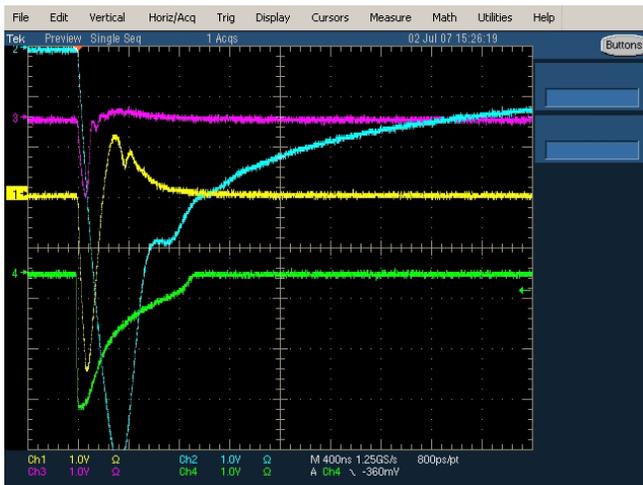
Fig. 9. Photocurrent response for non-responsive state

One of the devices in this series of tests also entered a non-responsive state at dose rates as low as 6×10^9 rad(Si)/s. The response was repeatable and occurred every time the dose rate exceeded that threshold. The device could not be reconfigured without cycling the power supply. The photocurrent waveform shown in Figure 9 has a very long recovery time which is probably not accurately followed by the CT-2 current probe due to amp*second product limitations. The dc current to the part increased from 174 mA pre-

irradiation to 300 mA after the pulse. The current was stable at that value until the supply was recycled.
